Geomorphology

Investigating feedbacks in human–landscape systems: Lessons following a wildfire in Colorado, USA

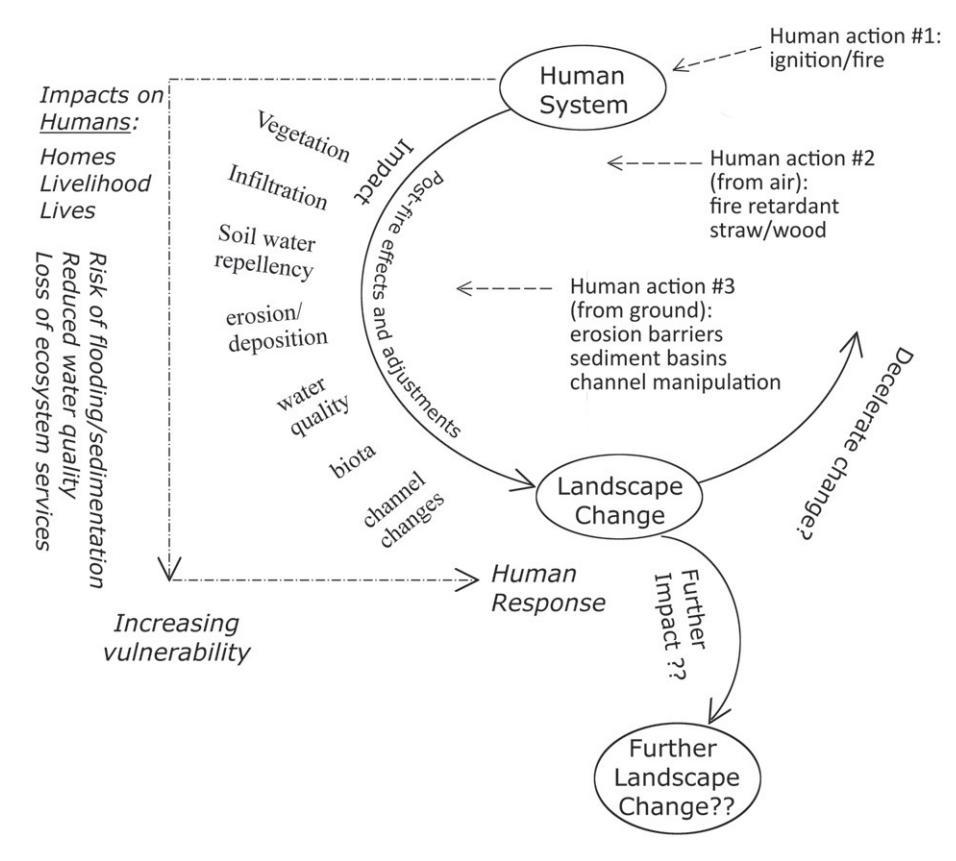
Fig. 2. Feedback interactions between human and fluvial landscape systems following the Waldo Canyon Fire.

Superimposed on the natural post-fire changes in the landscape, some of which are additionally influenced by human actions, is the direct toll of the fire itself on humans (Fig. 2; left side of diagram). Direct consequences of the Waldo Canyon Fire included loss of homes, livelihood, and even lives. Other impacts included post-fire risks of flooding, sedimentation, and reduced water quality. After wildfires, nutrient loadings and metal concentrations in streams typically increase from the burning of organics, along with sediment-laden floods (Ranalli, 2004; Mast and Clow, 2008; Burke et al., 2013). Therefore, the loss of ecosystem services and risks associated with post-fire effects often leave residents feeling vulnerable (Simon, 2012). As homeowners move out of burned areas, attrition also impacts residents' sense of community and well-being (McGee and Russell, 2003; Carroll et al., 2005). The increasing vulnerability of communities, in turn, often prompt human responses that further trigger additional feedback interactions, promoting or inhibiting further landscape change (Fig. 2).

Because of the incipient erosion downstream of the fences, a decision was made by March 2014 to pave the eroded segment of channel immediately downstream of the lower fence (Fig. 7a). This decision represented another human response to the erosion triggered by the first decision to install the fences, and by the subsequent unintended effects of the fences. The pavement will certainly inhibit erosion locally, but it will also further decrease roughness, thereby increasing velocity and erosive capacity downstream. Such erosion was already evident in the surveyed longitudinal profile of 21 March 2014 (at approximately 55 m where the pavement ends; Fig. 4). The continuing erosion downstream of the paved area prompted yet another decision to ultimately fill and channelize the entire creek below the lower fence (Figs. 7b and 8), thereby connecting it to the urban concrete channel farther downstream in Colorado Springs. The initial decision to construct the fences therefore ultimately determined the fate of the channel downstream. Although the decision was a human response to the threats of post-fire geomorphological hazards, the transition to the urban channelized stream from its previous natural state was, in the end, not a direct geomorphic consequence of wildfire. The human decision to construct the fences had the unintended consequences of promoting further landscape change in a positive feedback loop (Fig. 2).

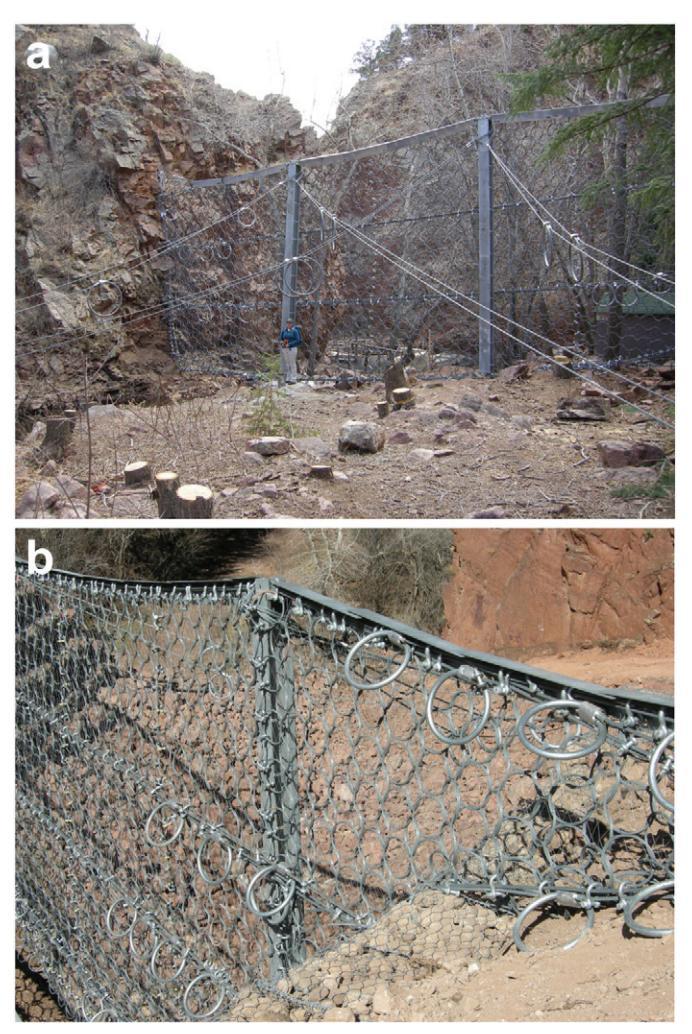
Fig. 3. (a) Upper fence with person for scale; (b) Fence showing rings and smaller mesh with 113 mm opening. Photos taken 7 April 2013.

One such human response to the Waldo Canyon Fire was the construction of two tall fences at the mouth of the Camp Creek watershed (Figs. 1 and 3). Private citizens built these fences in Spring 2013, in anticipation of the first post-fire season of summer storms, which they feared might trigger flooding and debris flows. Both fences are 6.4 m high with two layers of openings: a set of larger rings of approximately 30 cm in size, and a smaller mesh with openings of 11.3 cm (Fig. 3b). The smaller, flexible ring nets help the fence withstand high static and dynamic loads (Geobrugg, n.d.). Support ropes on both sides of the fence are intended to reduce the impact of debris by transferring the pressure load to the ground (KANE GeoTech, Inc., 2012). The upstream fence is ~21 m wide at the top and ~15 m wide at the bottom (Fig. 3a). The downstream fence, ~25 m wide at the top and ~12 m at the bottom, was designed to accommodate an adjacent utility road for routine maintenance (Jordan, 2013). The two fences are spaced approximately 400 m apart and are expected to remain in place for at least 8 years (Strickler, pers. comm., 2012). Together, they are intended to trap sediment and debris from reaching the base of Camp Creek, thereby protecting communities downstream.

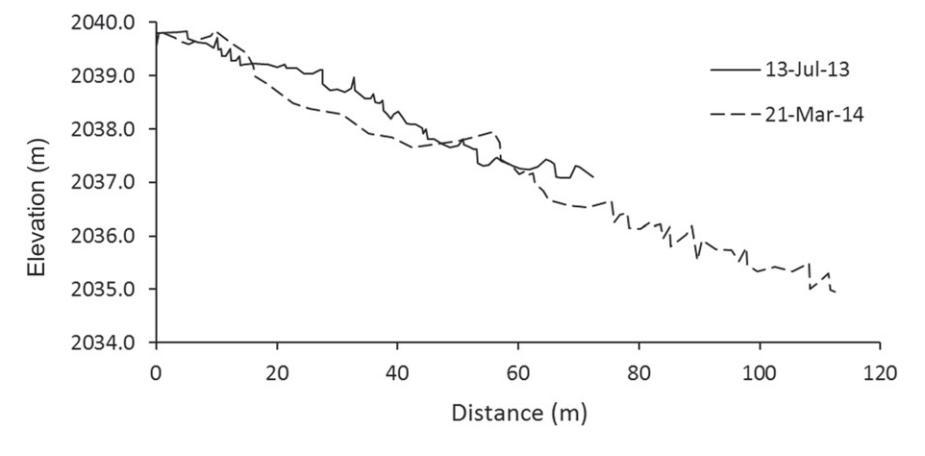
Fig. 4. Longitudinal profile of study reach below fences: 13 July 2013 and 21 March 2014.

The field measurements produced results as hypothesized, along with a few surprises. The longitudinal profile on 13 July 2013 below the downstream fence (Fig. 4) represents the channel morphology largely unaffected by the fences; the fences were built during a dry period just a few months before this date. The flows of summer and fall 2013, however, included several events exceeding the critical discharge for transport of coarse sediment greater than the size of the openings in the fence $(1.83 \text{ m}^3/\text{s})$. These flows occurred on 9 August with a peak of $6.54 \text{ m}^3/\text{s}$, as well as during the period of 11-14 September in response to prolonged and intense rainfall events. These precipitation events also produced major flooding along other areas of the Colorado Front Range (Gochis et al., 2015). Although peak discharges at the Camp Creek at Garden of the Gods, CO gauging station (Station I.D. 07103703) are not available for 12-14 September 2013, the gage

recorded an instantaneous peak value of $3.23 \text{ m}^3/\text{s}$ on 11 September, and mean daily discharges of $3.99 \text{ m}^3/\text{s}$, $6.14 \text{ m}^3/\text{s}$, and $2.97 \text{ m}^3/\text{s}$ for 12, 13, and 14 September, respectively. The gage also registered a peak discharge of $1.93 \text{ m}^3/\text{s}$ on 17 September 2013. These flows, therefore, had capacity to transport particles larger than 113 mm median diameter into the study reach downstream of the fences. The movement of particles of this size if now blocked, however, by the fences (Fig. 5). By the following spring (21 March 2014), the surveyed profile showed degradation of the channel bed by nearly one meter (Fig. 4).

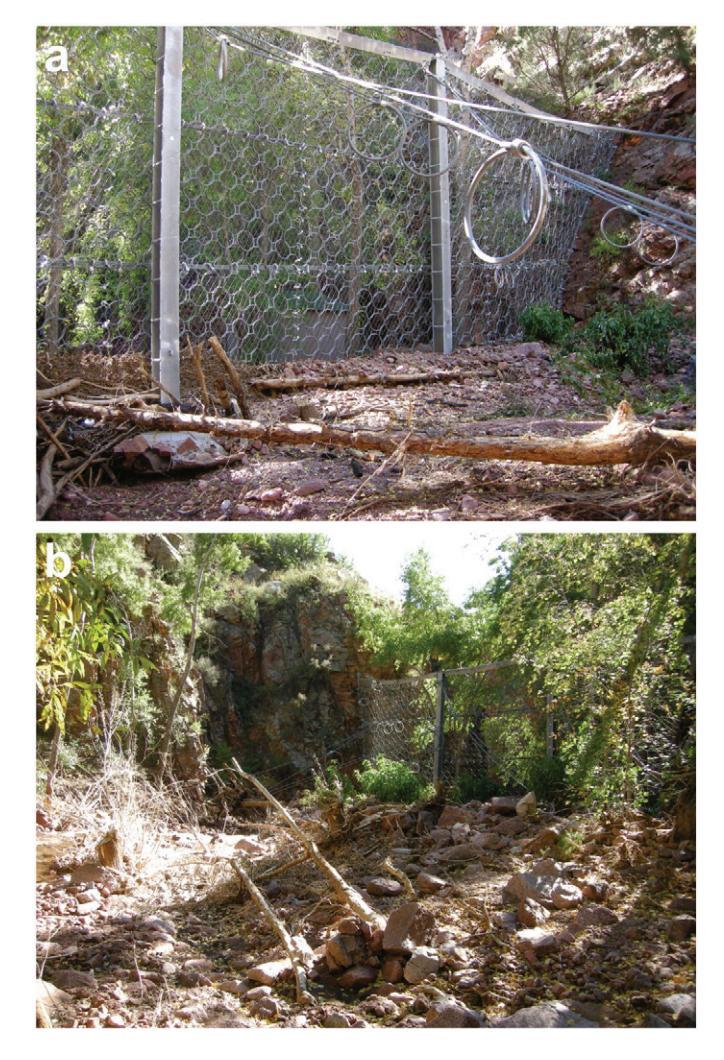
Fig. 5. Upper fence blocking particles from transport downstream. Photos taken 3 October 2013.

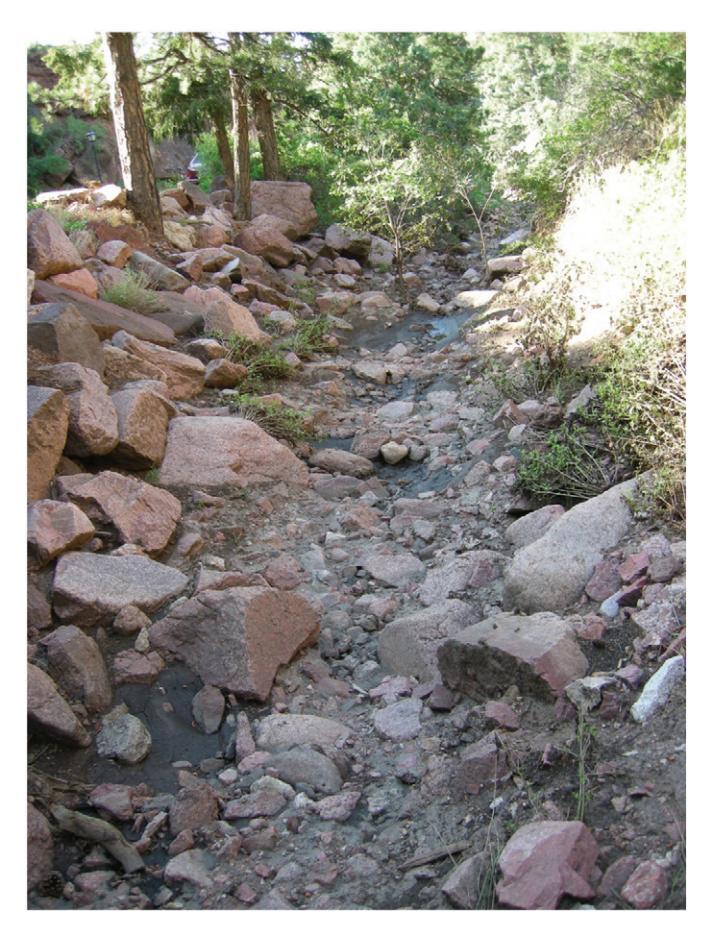
Fig. 6. Channel character downstream of lower fence before construction.

These results suggest that the fences have an unintended consequence of facilitating erosion downstream, even though they may stop large objects from causing other damages. Further, as coarse particles that are present downstream of the fences are transported down the basin and are not replaced by materials upstream, the channel loses roughness elements that promote energy dissipation in the mountain fluvial system. Over time, decreasing roughness should lead to even higher erosive capacity. Devoid of coarse particles, the channel may also change from a step-pool morphology (Fig. 6) to a plane bed over time.

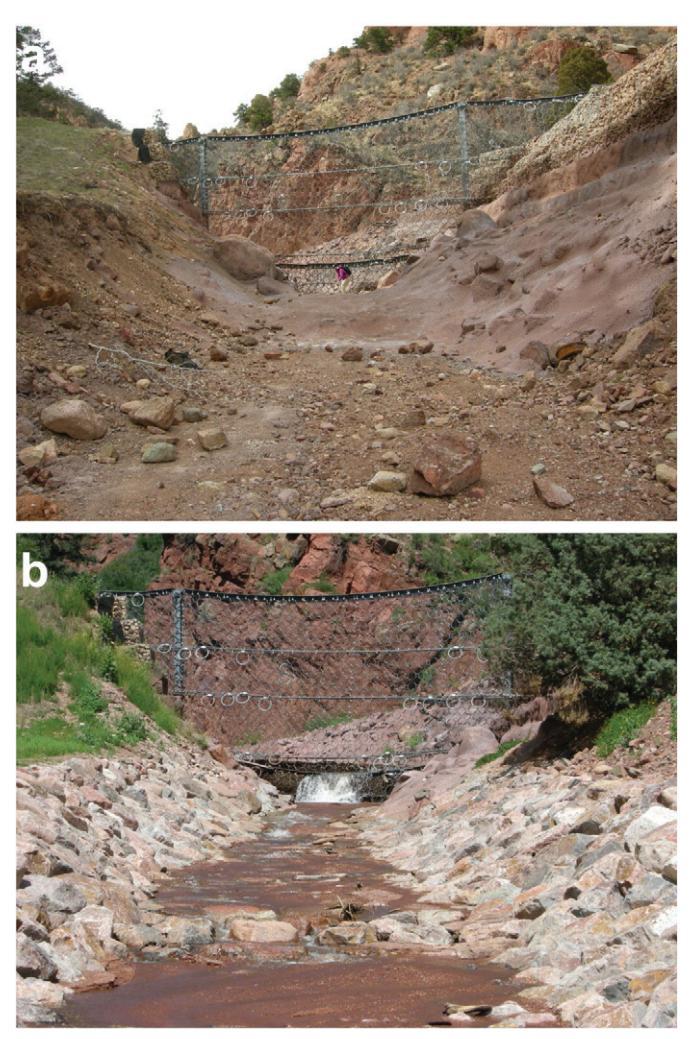
Fig. 7. (a) Paved channel bed and banks extending ~60 m downstream of lower fence, 21 March 2014; (b) Channelized reach downstream of lower fence, 9 August 2014.

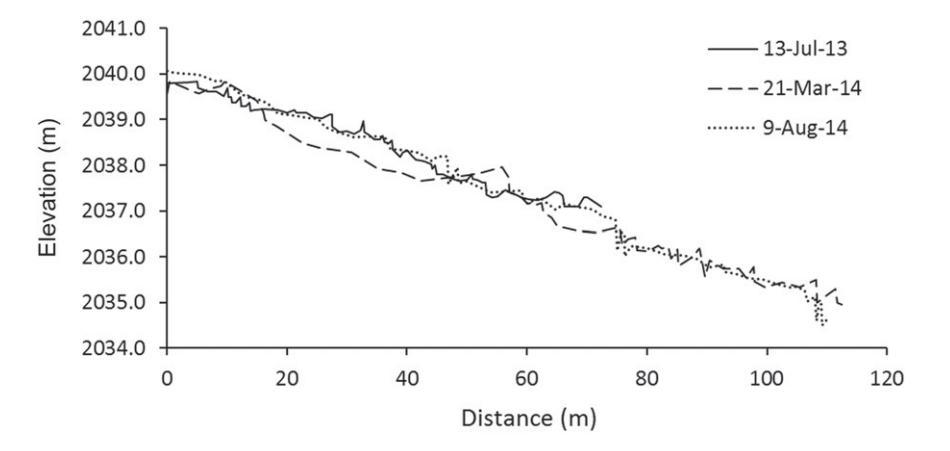
Fig. 8. Longitudinal profile of channelized reach downstream of lower fence, 9 August 2014.

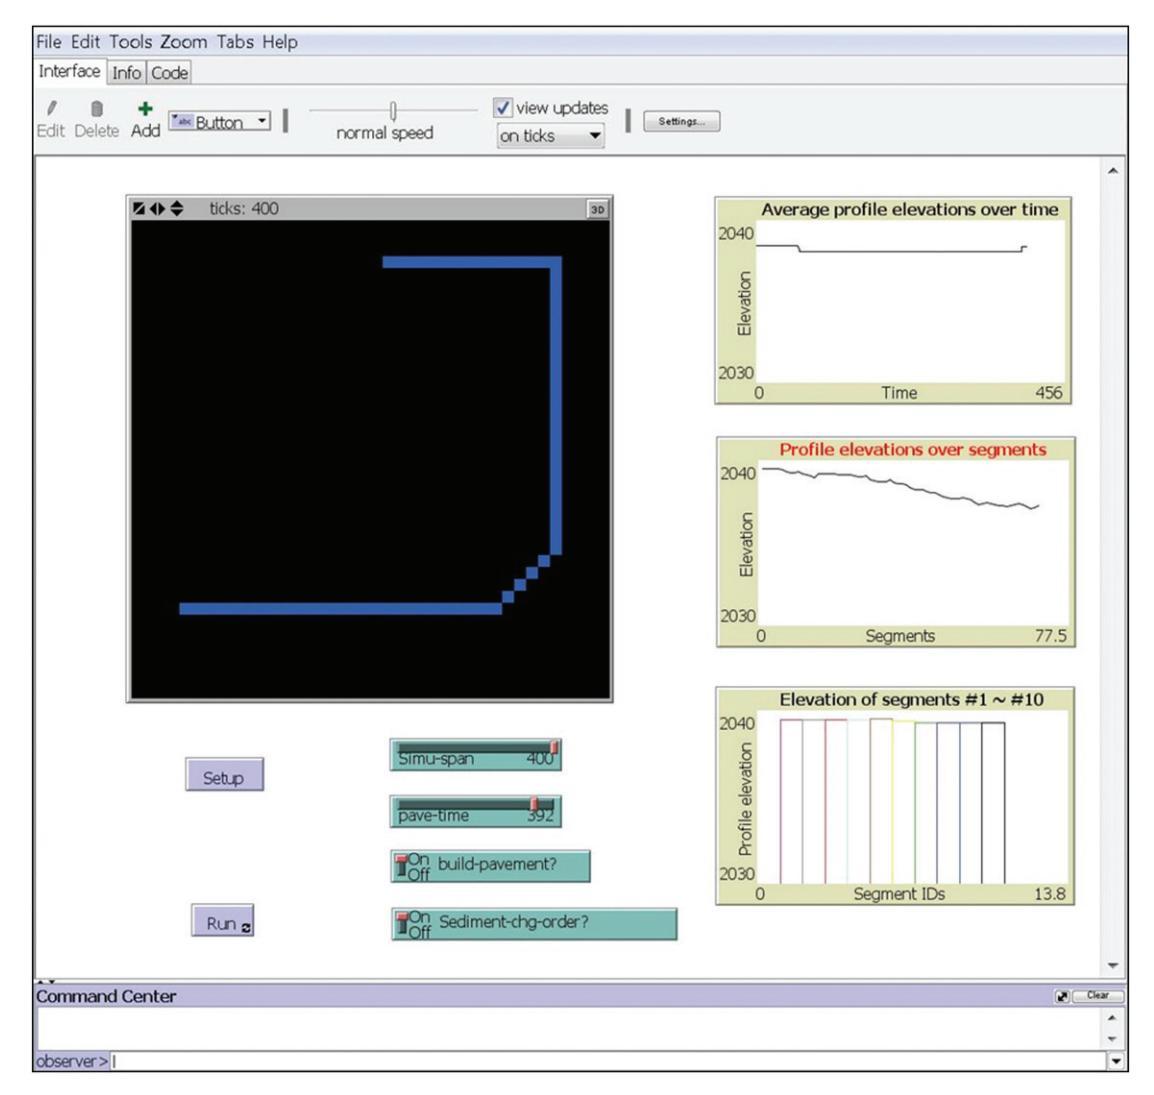
Fig. 9. The interface of the agent-based model developed in NetLogo. The window on the left represents the study channel against a black background depicting the neighboring hypothetical landscape (40 cells by 40 cells). The initial time (time zero) for this simulation is 13 July 2013. The graphs on the right show the average elevation of all 70 segments over time, the surface (profile) elevation of the segments at discrete time points (in this example, for day), and an illustrative elevation of the profile for the first 10 segments below the fence.

In this ABM, we conceptualized a 70 m study channel reach as a linear feature comprised of 70 connected linear segments, with each segment 1 m long (Fig. 9). Each segment is considered an agent or object in the model. Each segment agent has several key attributes: the elevation of the subsurface bedrock, the thickness of the alluvial sediment layer overlying bedrock, and the average elevation of the channel segment that equals the bedrock elevation plus sediment thickness. Assuming that the elevation of the subsurface bedrock is constant over the timespan of the study, the elevation of the channel segment

NetLogo provided a freely available software package for coding the ABM (Fig. 9). We set t to 0 (the initial time) to represent the time that the fence is built, the first human response. To represent the second human response (the channel paving), we reset the sediment thickness to zero $(E_{sediment}(t) = 0)$ while raising the elevation of the bedrock (E_{bedrock}), as outlined in rule 5. To represent these aggregate level human decisions, we set an observer-level agent (corresponding to system manager or policy maker) and represent his/her decisions in the ABM about whether to build a pavement and if so, when to build it. The two bars in Fig. 9, named "build-pavement?" and "pave-time?", represent these decisions, respectively. The other two bars in Fig. 9 are other observer-level agent decisions: time span of the simulation (the bar "Simu-time") and the way sediment thickness may change in response to flow changes (the bar "Sediment-chg-order"; Fig. 9). The time span can be set as high as 400 steps (days; adjustable to any number of interest). The default for the change in sediment thickness change follows the preliminary rules outlined above (i.e., when the "Sediment-chg-order" bar is set at "on"). When the "Sediment-chgorder bar" is set at "off", the thickness of all segments decreases simultaneously at a rate determined by rules 1-3 until it becomes zero (this option is primarily for the purpose of testing the model). To test the ABM, we compared the predicted segment elevations at discrete time steps with the March 2014 survey following the model verification and validation procedures in An et al. (2005, 2014). The simple test results show that the simulated profiles compare well with observed data (Fig. 10). Although this preliminary model uses limited data in a hypothetical landscape setting, it provides a basis for further development and testing.

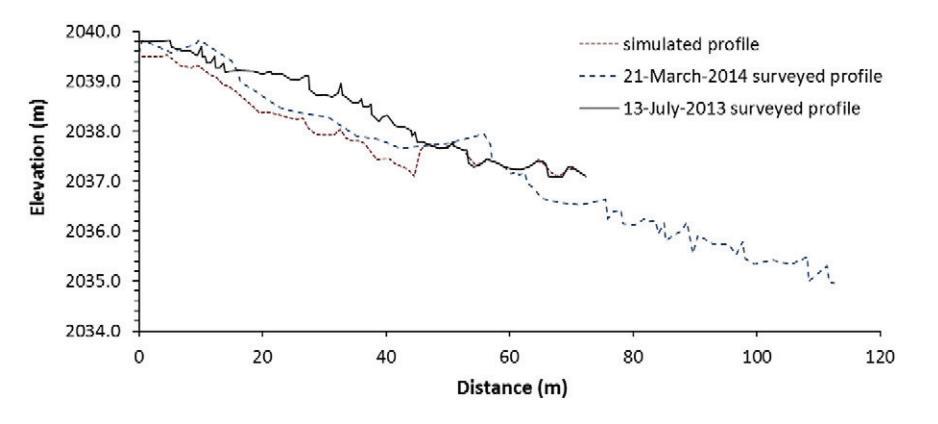
Fig. 10. Simulated profile resulting from ABM compared with topographical surveys.
